Photographic Log

Site Name:		Site Location:	Tracking No.:
Piperton Class Change Project		Highway 57 and Hwy 196 near the Wolf River	TNR154033
Photo No.	Date

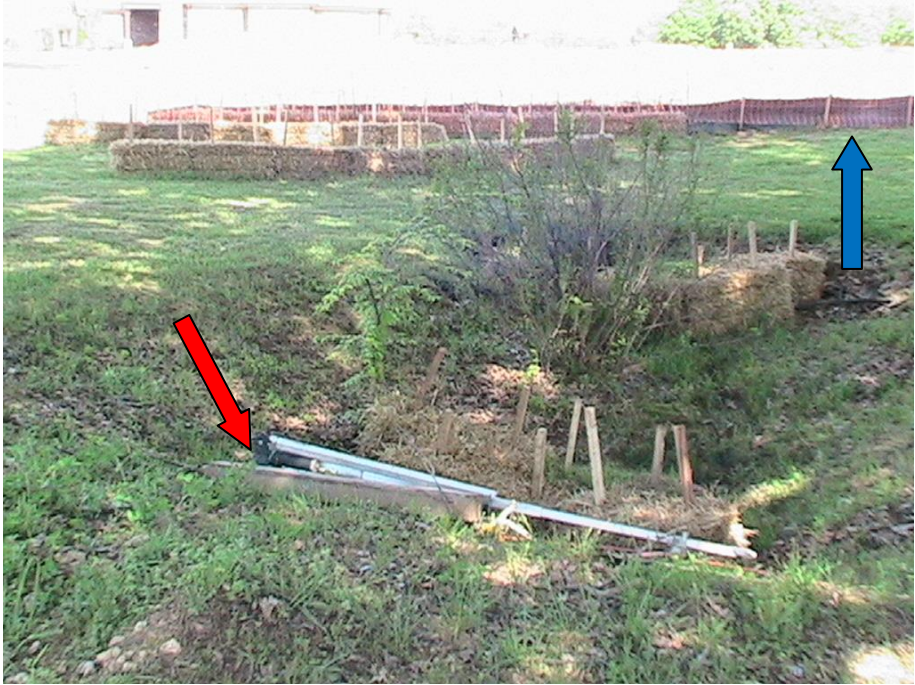
1	4/22/15		
Description This photo is looking up-gradient at the drainage path from an area of the project which apparently discharged during a significant rain event the week before (week of April 12-18, 2015). A storm drain inlet (red arrow) is in the foreground, and additional hay bales that project personnel installed after the event (as explained by project personnel) are visible. Silt fence along the edge of the active project is visible in the background (blue arrow).			
Photo No.	Date

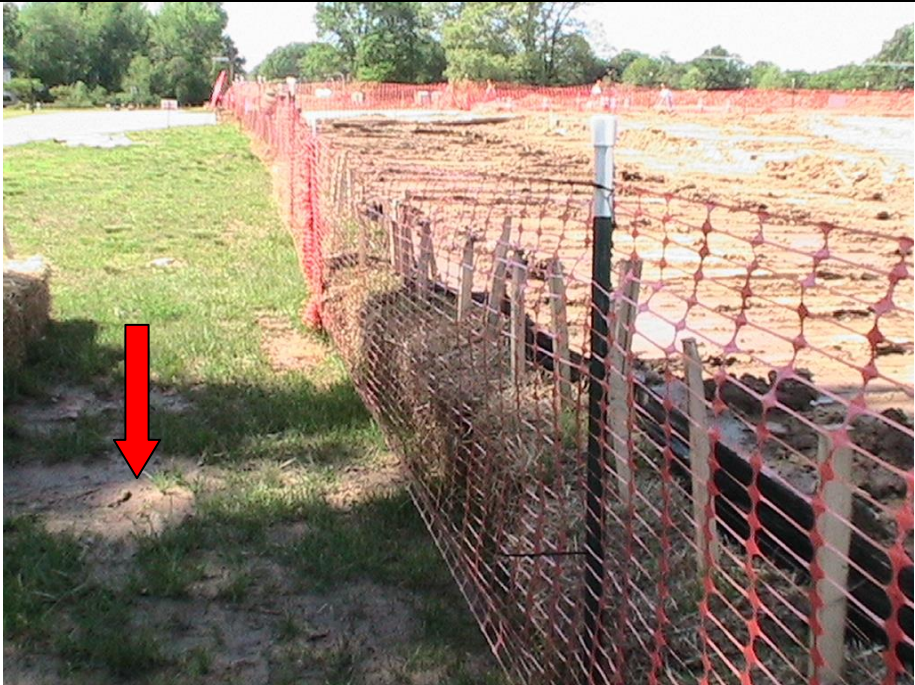
2	4/22/15		
Description This is a close-up view of the silt fence where the sediment-laden storm water discharged from the site. The drainage path shown in photo 1 is to the left of the photo. Accumulated sediment was observed down-gradient from the silt fence (red arrow).

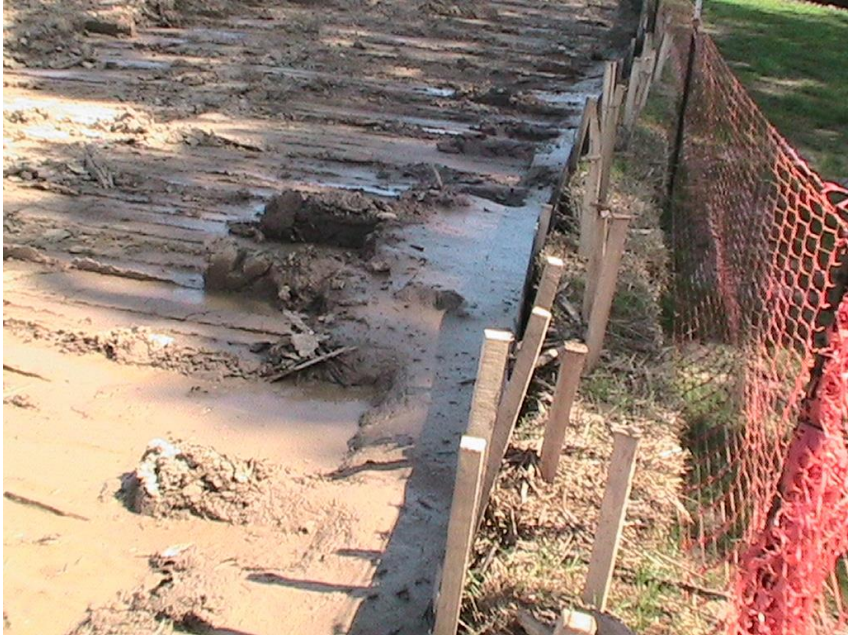
Site Name:		Site Location:	Tracking No.:
Piperton Class Change Project		Highway 57 and Hwy 196 near the Wolf River	TNR154033
Photo No.	Date		
3	4/22/15		
Description This is a close-up view of the up-gradient/construction side of the area shown in photo 2. It shows a low area where sediment has accumulated. Although it is not clearly visible it appeared that the sediment had accumulated at or beyond 50% capacity of the silt fence.

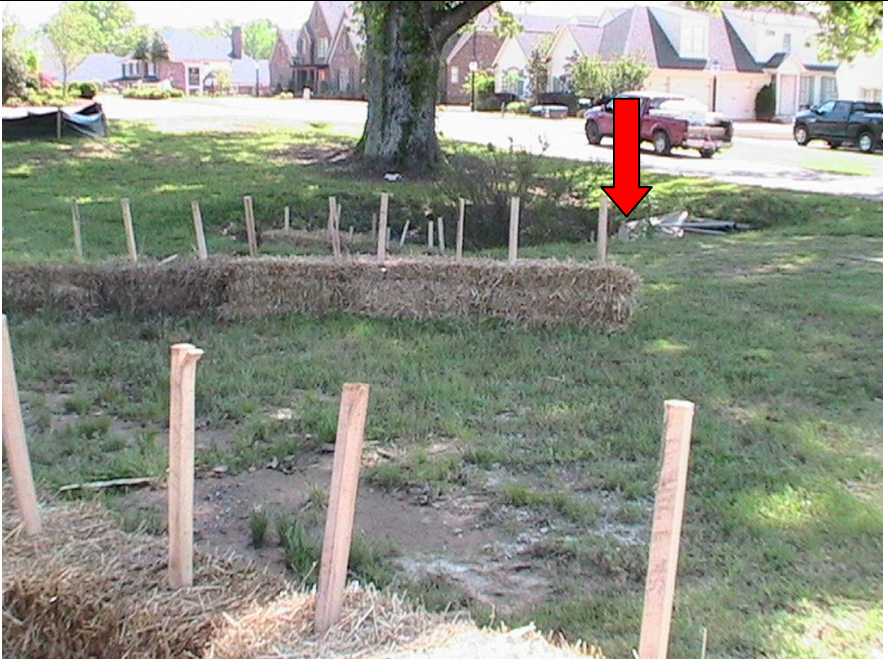
Photo No.	Date		
4	4/22/15		
Description This is a view of the drainage path discussed in previous photos looking down-gradient from the construction site. The vicinity of the storm drain inlet is indicated by the red arrow.

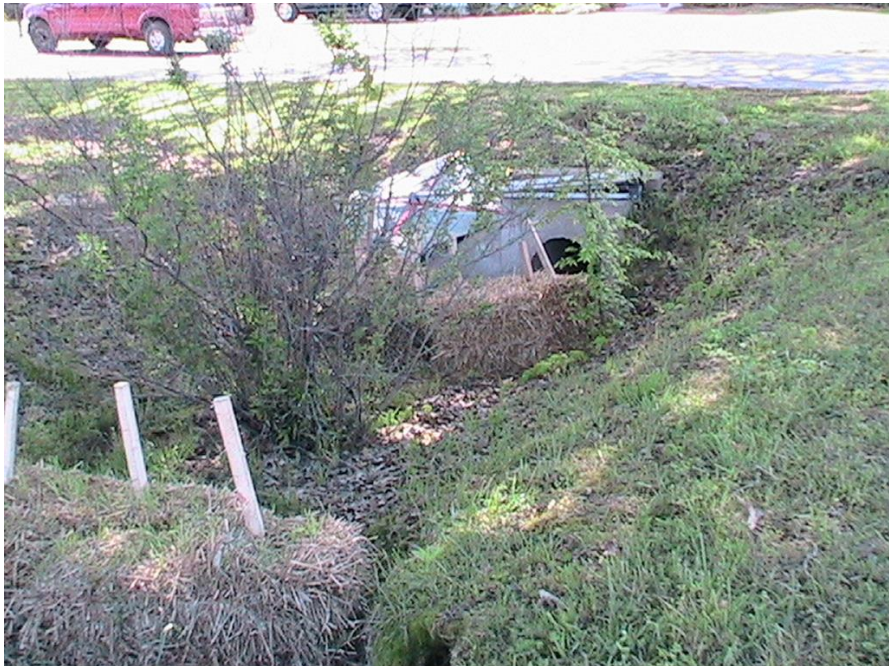
Site Name: Piperton Class Change Project		Site Location: Highway 57 and Hwy 196 near the Wolf River	Tracking No.: TNR154033
Photo No. 5	Date 4/22/15

Description This is a view of the storm drain inlet discussed in photos 1 & 4 above.

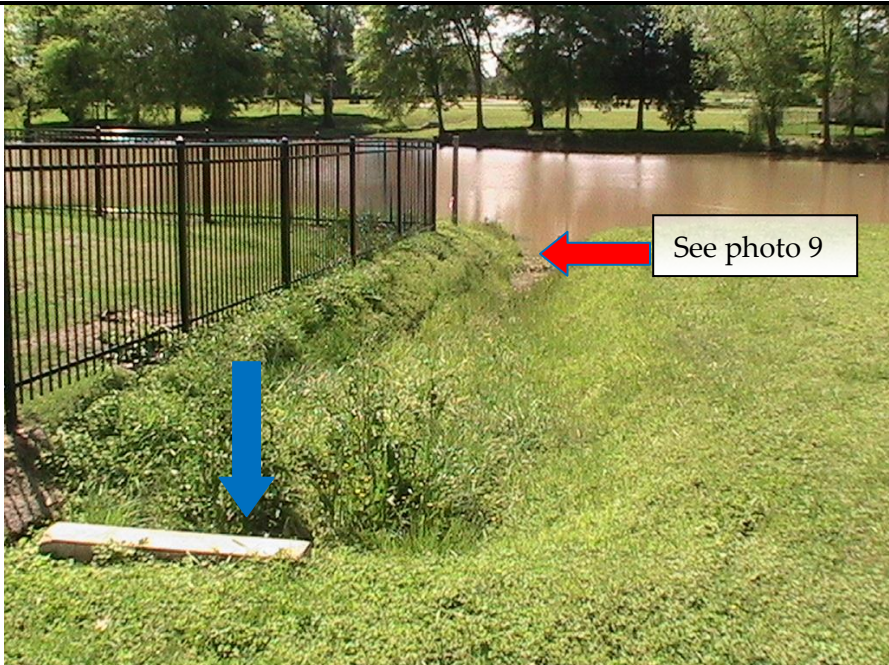
6	4/22/15

Description
This is a view of the outlet from the storm drain inlet previously discussed. A grassy swale connects the outlet (blue arrow) to the main Twin Lakes subdivision lake. See photo 9 for a closer view of the area indicated by the red arrow.

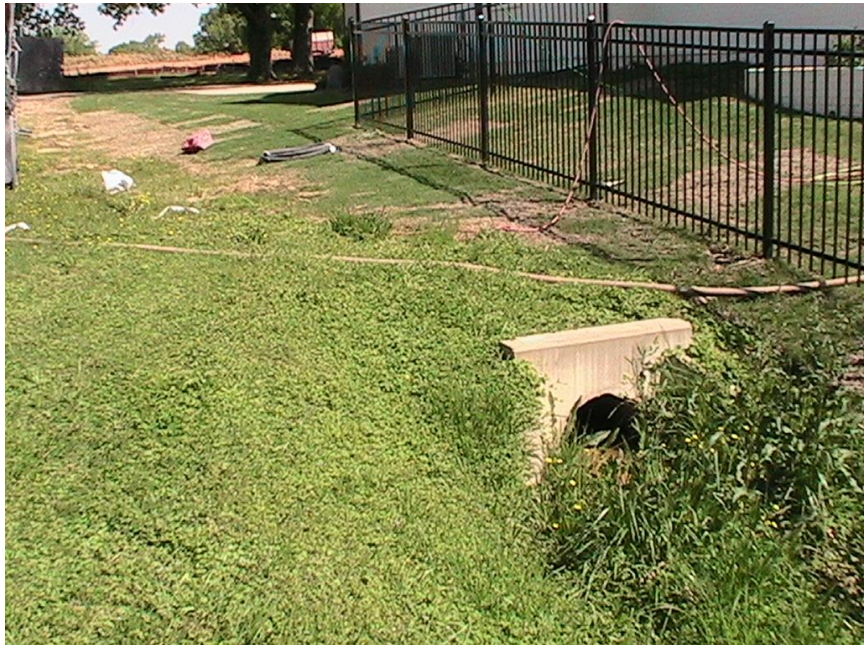
Site Name: Piperton Class Change Project		Site Location: Highway 57 and Hwy 196 near the Wolf River	Tracking No.: TNR154033
Photo No. 7	Date 4/22/15

Description This is a view of the outlet mentioned in photo 6 looking up-gradient. The project location shown in photos 2 & 3 is out of view at the upper left of the photo.

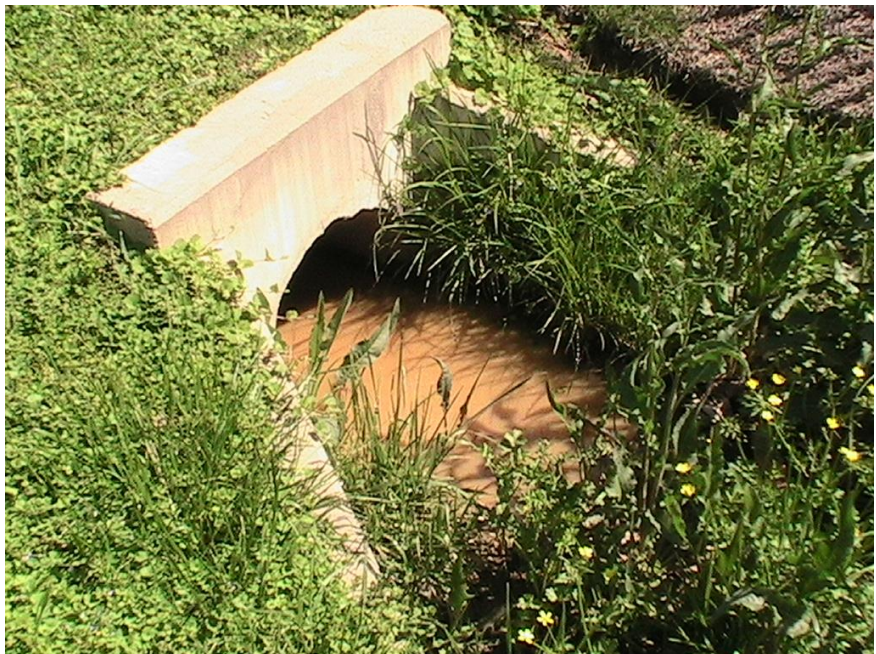
8	4/22/15	
Description This is a close-up view of the outlet structure. Standing water was observed that appeared to be sediment-laden. This indicates that sediment-laden water has discharged at this location.

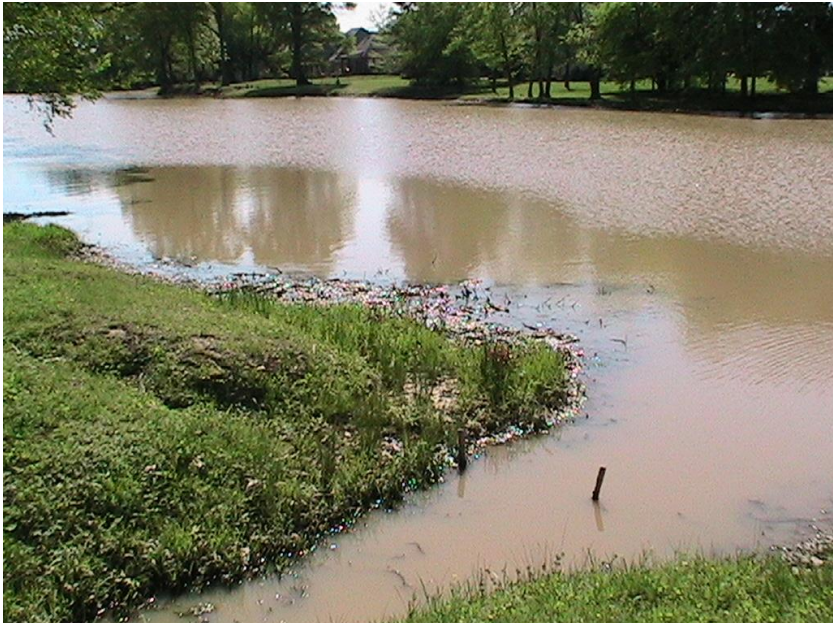
Site Name: Piperton Class Change Project		Site Location: Highway 57 and Hwy 196 near the Wolf River	Tracking No.: TNR154033
Photo No. 9	Date 4/22/15

Description This is a view of the main lake in Twin Lakes subdivision where the drainage channel from the outlet discussed in photos 6 through 8 and referenced with an arrow in photo 6 enters the lake.
